ESP32-S2 Series SoC

Errata

This document describes known errata in ESP32-S2 series of SoCs.

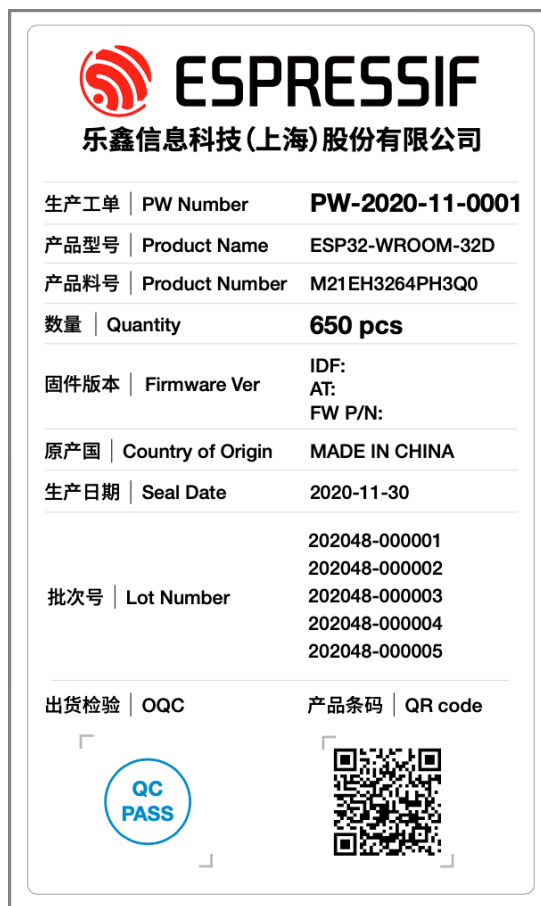
Figure 2: Module Product Label

Modules built around the chip may be identified by **PW Number** in product label (see Figure 2). For more information, please refer to [Espressif Module Packaging Information](#).

Please note that **PW Number** is only provided for reels packaged in aluminum moisture barrier bags (MBB).
